HYDRAULIC RAM EFFECT ON COMPOSITE FUEL CELL ENTRY WALLS

Alfred Nicholas Duva Jr.

March 1976

MASTER OF SCIENCE IN AERONAUTICAL ENGINEERING

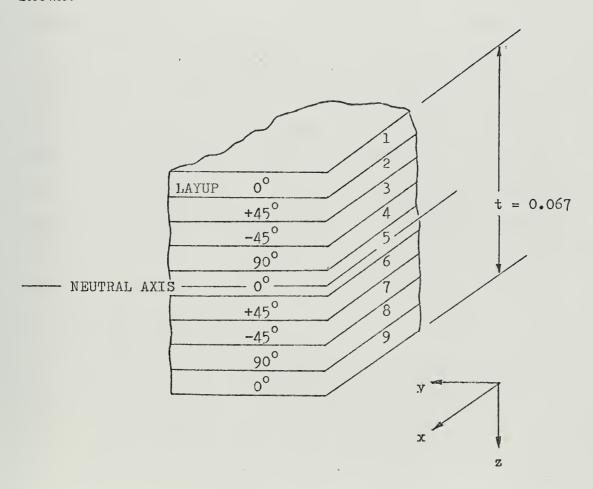
FIGURE III.A.1 - Test Laminate

The dimensions of antisymmetric angle-ply test laminates were 12 by 12 by 0.067 inches. Visual examination of the test plates revealed overall warping and considerable delamination. This condition, directly effecting the strength and stiffness of the laminate, may be attributed to an improper curing process.

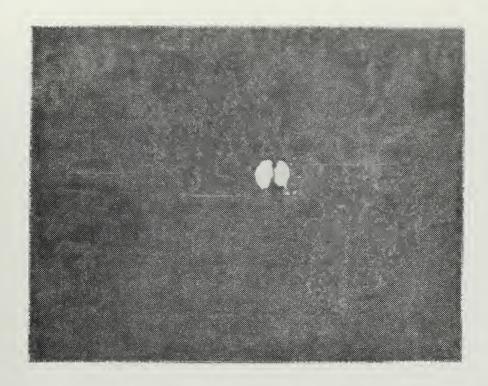
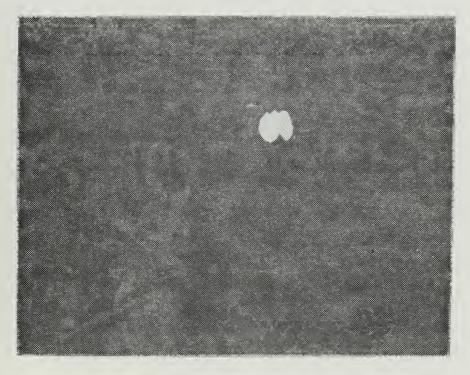
Figure V.B.? - Impact Damage Area

Two damage areas in the composite plates became evident during the testing with hydraulic ram; the impact area about the center of the plate caused by projectile penetration and the area in the vicinity of the clamped edge. Other than the hole due to the projectile penetration, the impact area damage was limited to delamination of the outermost plies of the plate dry face. Surface delamination was evident for as much as 0.50 to 2 inches on each side of the hole. No significant delamination of the plate wet face was observed. Figure V.B.1 shows the impact area damage of both the wet and dry face. The penetration holes in all test plates were essentially the same size as the projectile diameter; approximately 0.25 inches.

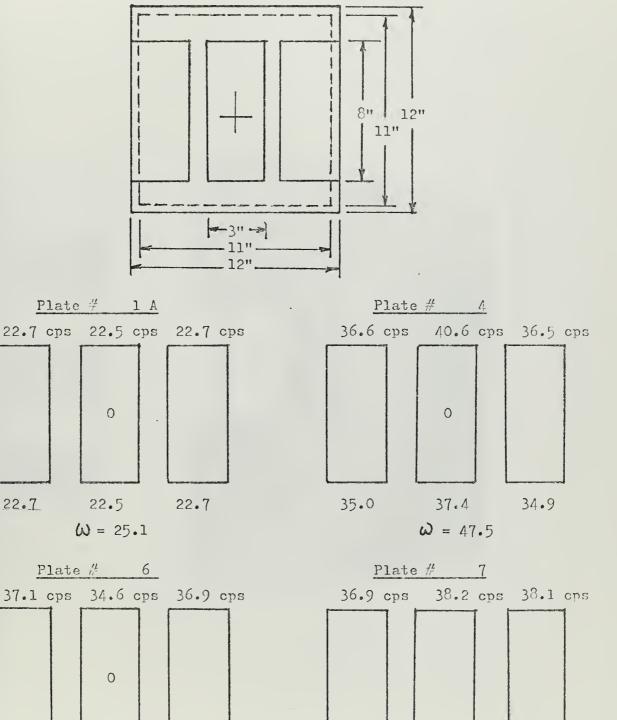
Location of Plate Specimens

When comparing the frequency of the center strip to that of the end strips of each plate tested, the following was observed: no significant frequency deviation of the aluminum plate (ballistic penetration with hydraulic ram) and the undamaged composite laminate (no ballistic impact); a 6-7 percent frequency decrease of the composite laminate subjected to ballistic penetration (no hydraulic ram); a 9 percent frequency increase of the composite laminate with both ballistic penetration and ram effect. Visual examination of the last laminate indicated probable delamination of the end strips caused by the clamped edge boundary damage.

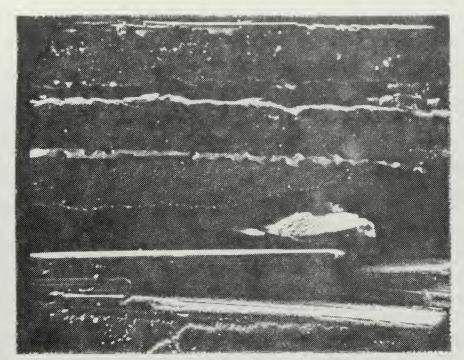
Figure VI.1 - Microscopic Plate Damage

The damage to the composite plates with hydraulic ram occurred in the impact area and along the outer perimeter. At the impact area, brittle fracture occurred (Figure VI.1) with significantly less delamination beyond the first and second laminae. However, the localized damage about the impact area is relatively insignificant when compared to the catastrophic

FRACTURE
Magnification 50x
